**Vehicle:** 2014-2016 Cadillac ATS, 2015-2016 Cadillac Escalade, 2015-2016 Chevrolet Suburban/Tahoe, 2015-2016 GMC Yukon

**GM #:** 16-NA-061

## Honda/Acura Noise Reducing Wheels

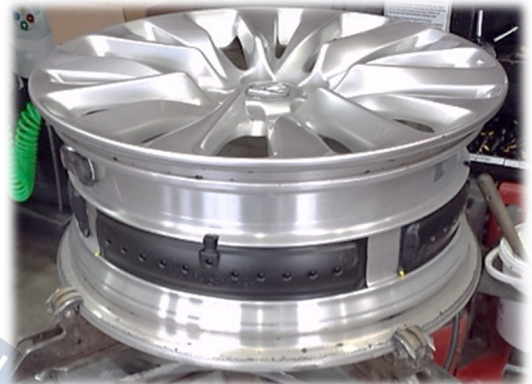
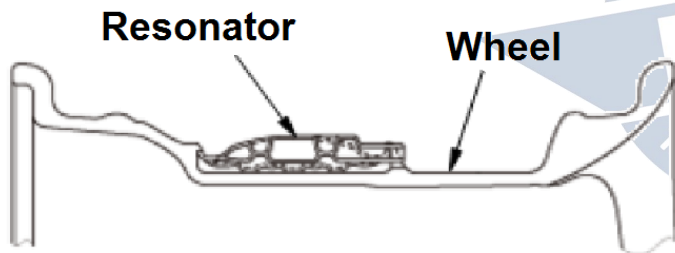
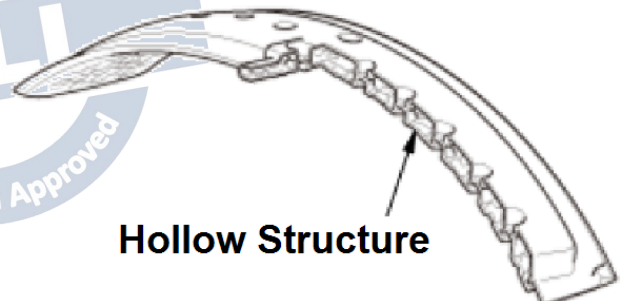
Certain Honda and Acura vehicles are equipped with Noise Reducing Wheels. Attached to the wheel barrel are four plastic resonators that help reduce the mid-frequency noise caused by the tire coming in contact with the road while in motion.

Tire service procedures are the same as a normal wheel but if any of the resonators are loose or damaged, the entire wheel will need to be replaced.

Noise Reducing Wheels can be found on models with Direct or Indirect TPMS.
